PRE & POST-OPERATIVE RADIOLOGICAL ASSESSMENT IN TOTAL KNEE REPLACEMENT

Dr. Divya Rani K
2nd Year Resident
Dept. of Radiology

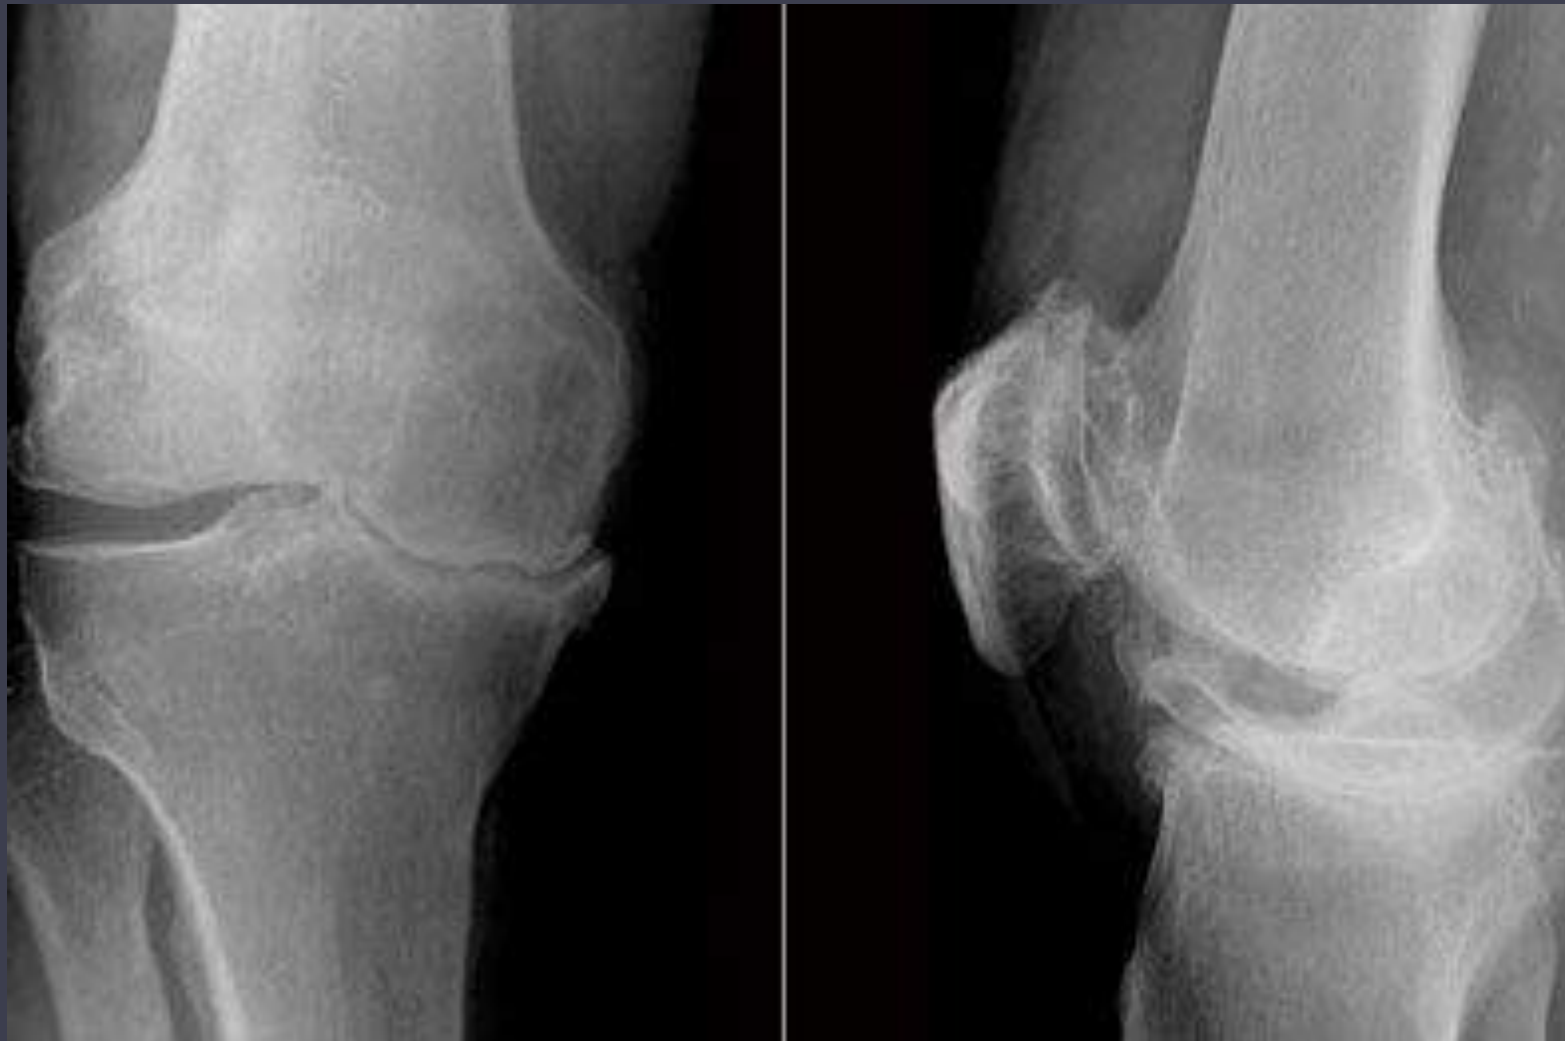
Advanced Osteoarthritis

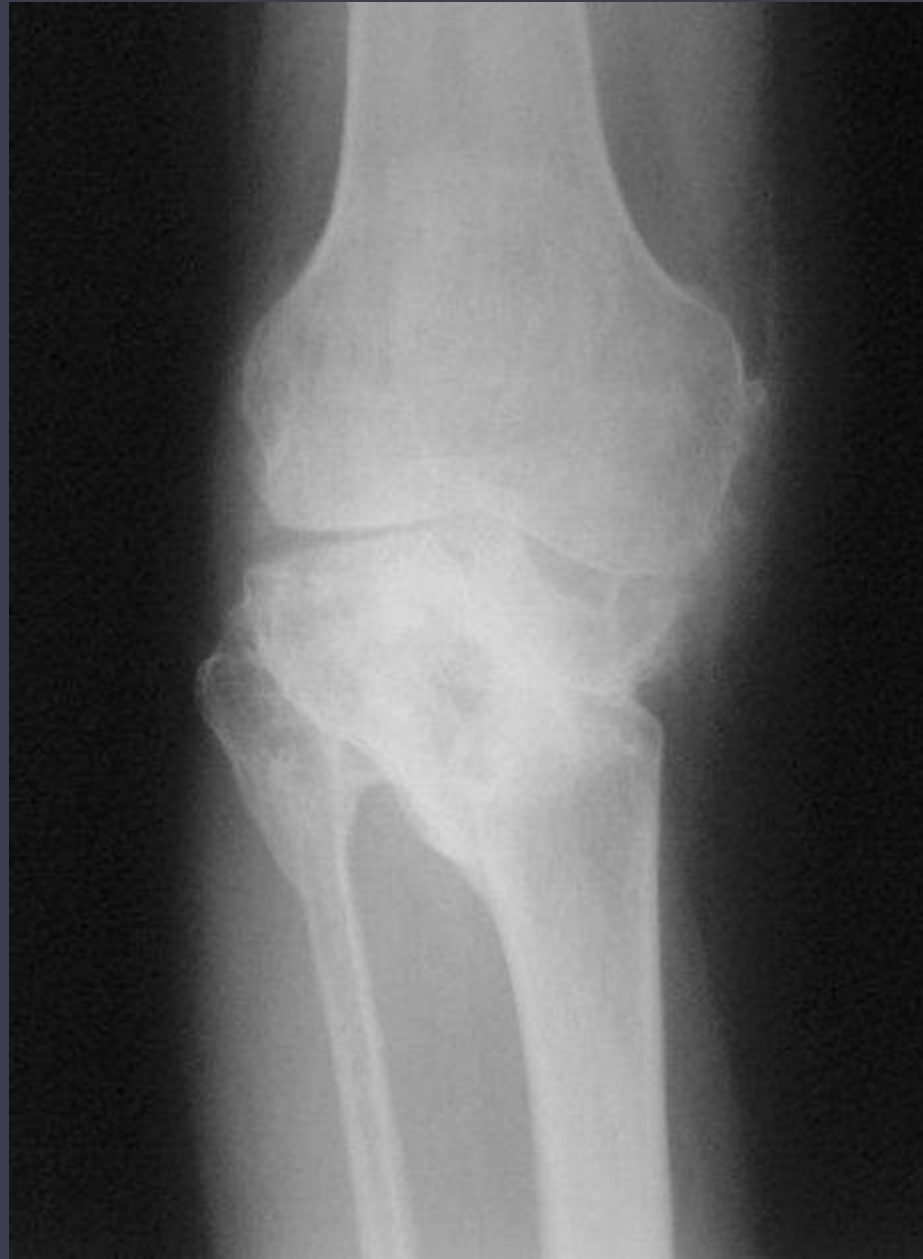
Post traumatic Osteoarthritis

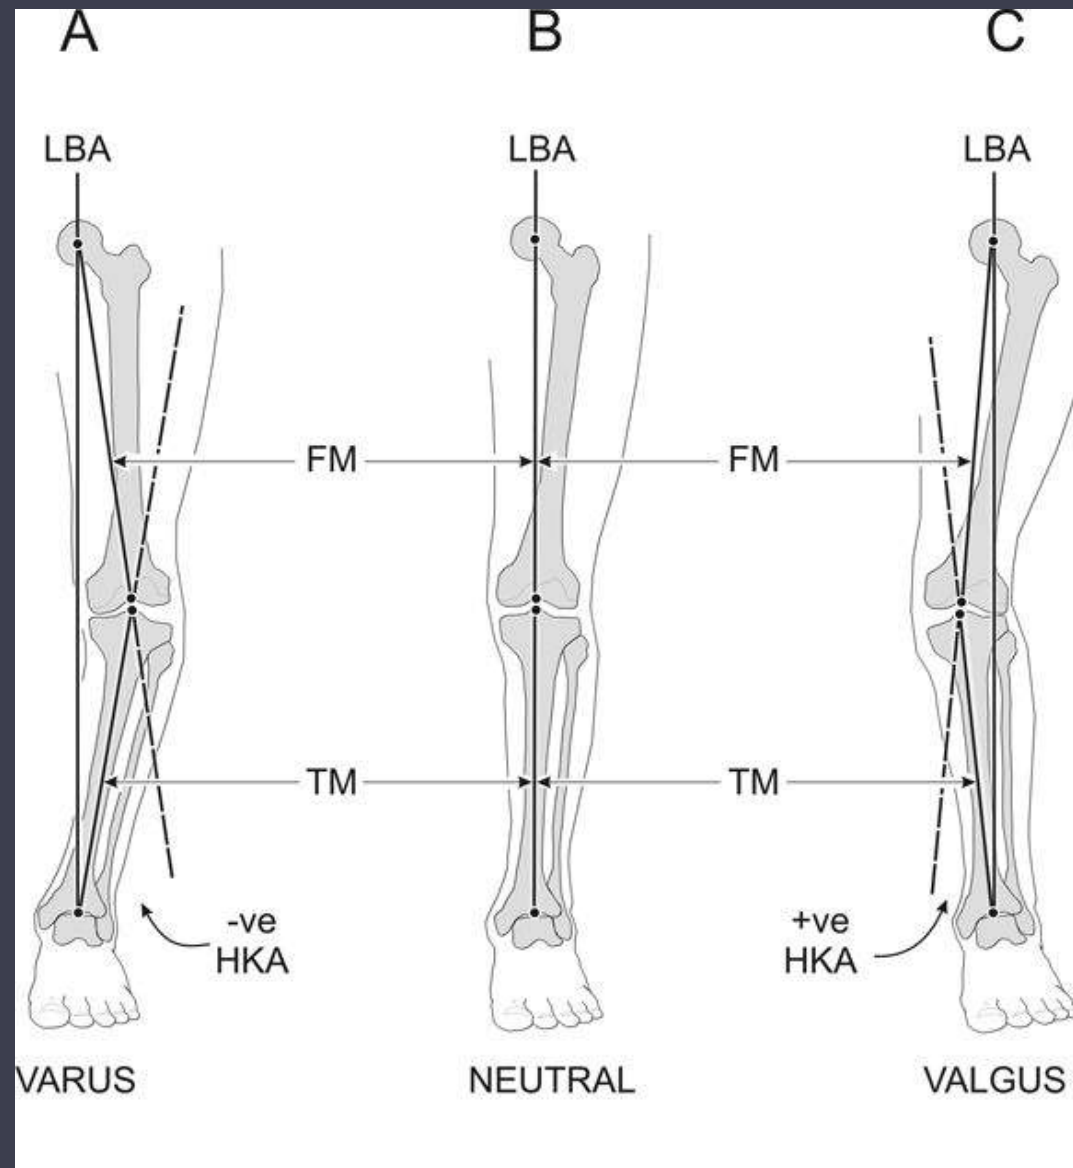
- A. Varus alignment: knee center is lateral to the LBA (HKA is negative)
- B. Neutral alignment: knee center is located on the LBA (HKA = 0°); femoral and tibial mechanical axes are colinear.
- C. Valgus alignment: knee center is medial to the LBA (HKA is positive).

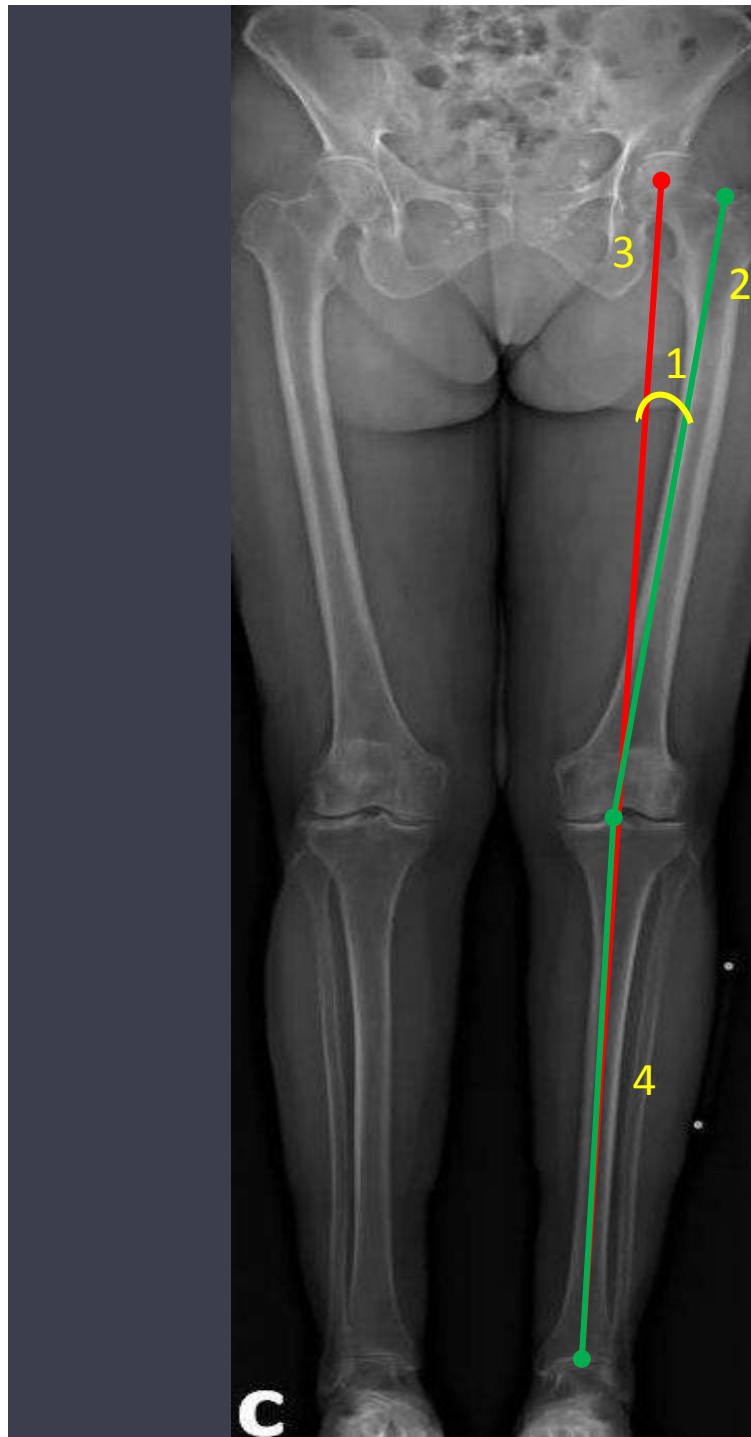
- (1) Angle between anatomical (2) and mechanical (3) axes of femur
- (4) Mechanical axis of tibia

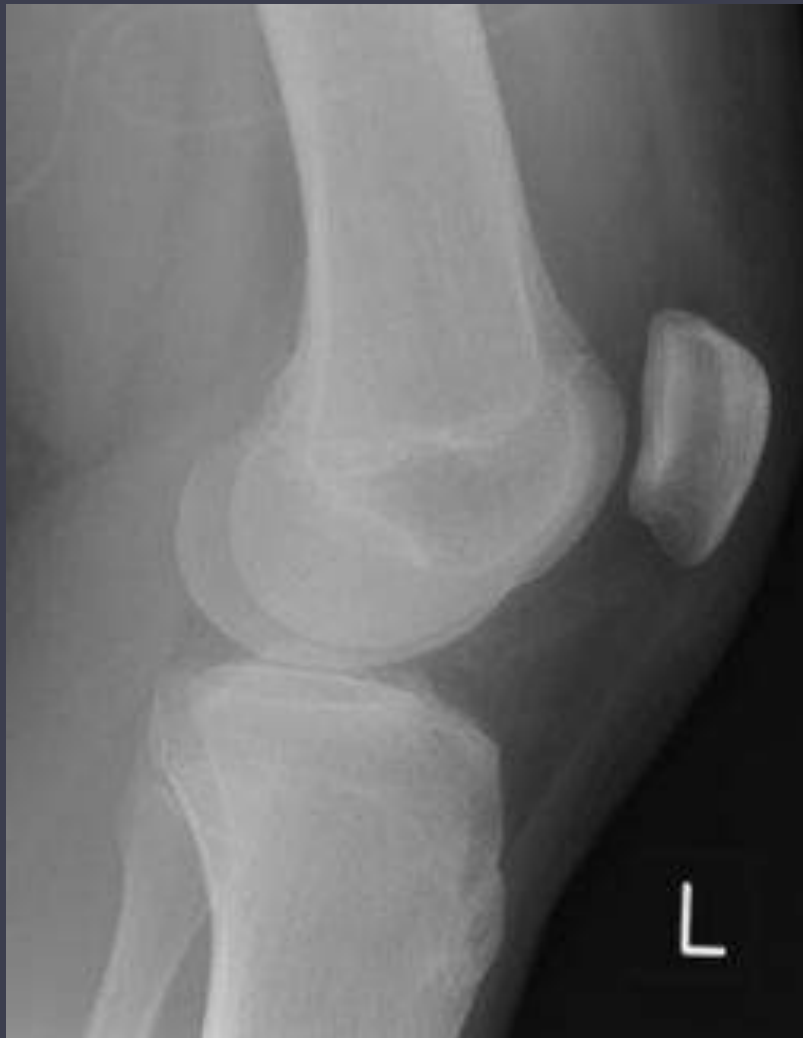
Patella alta

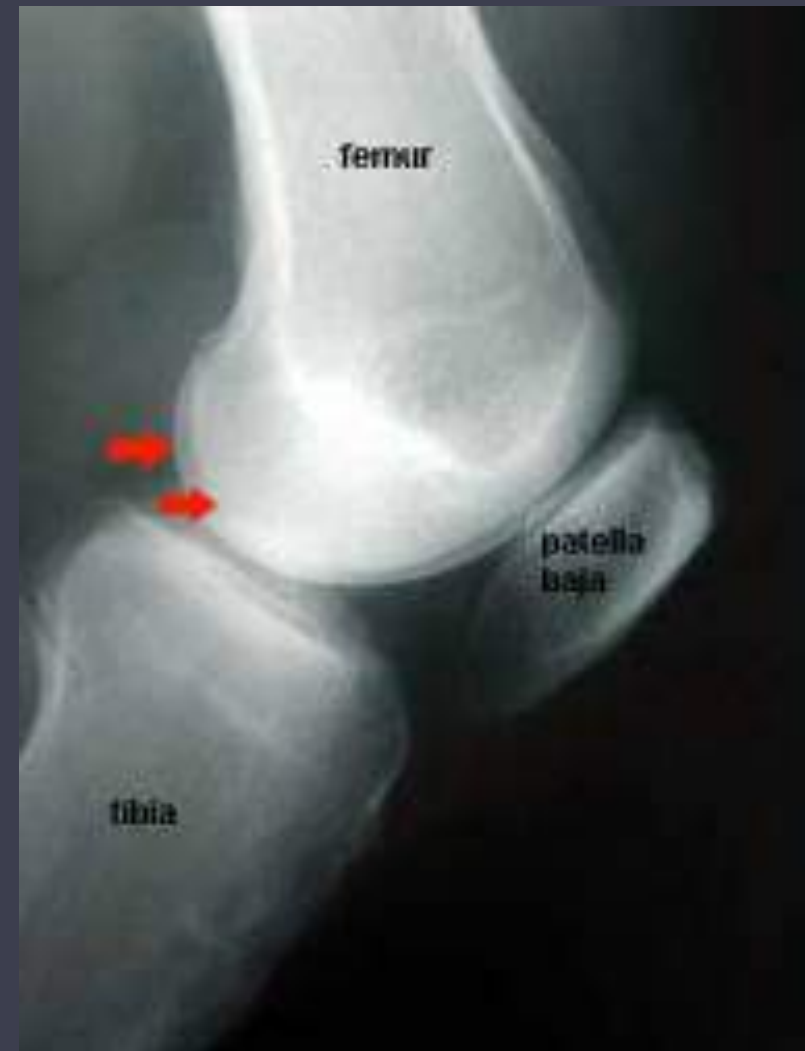
Patella baja

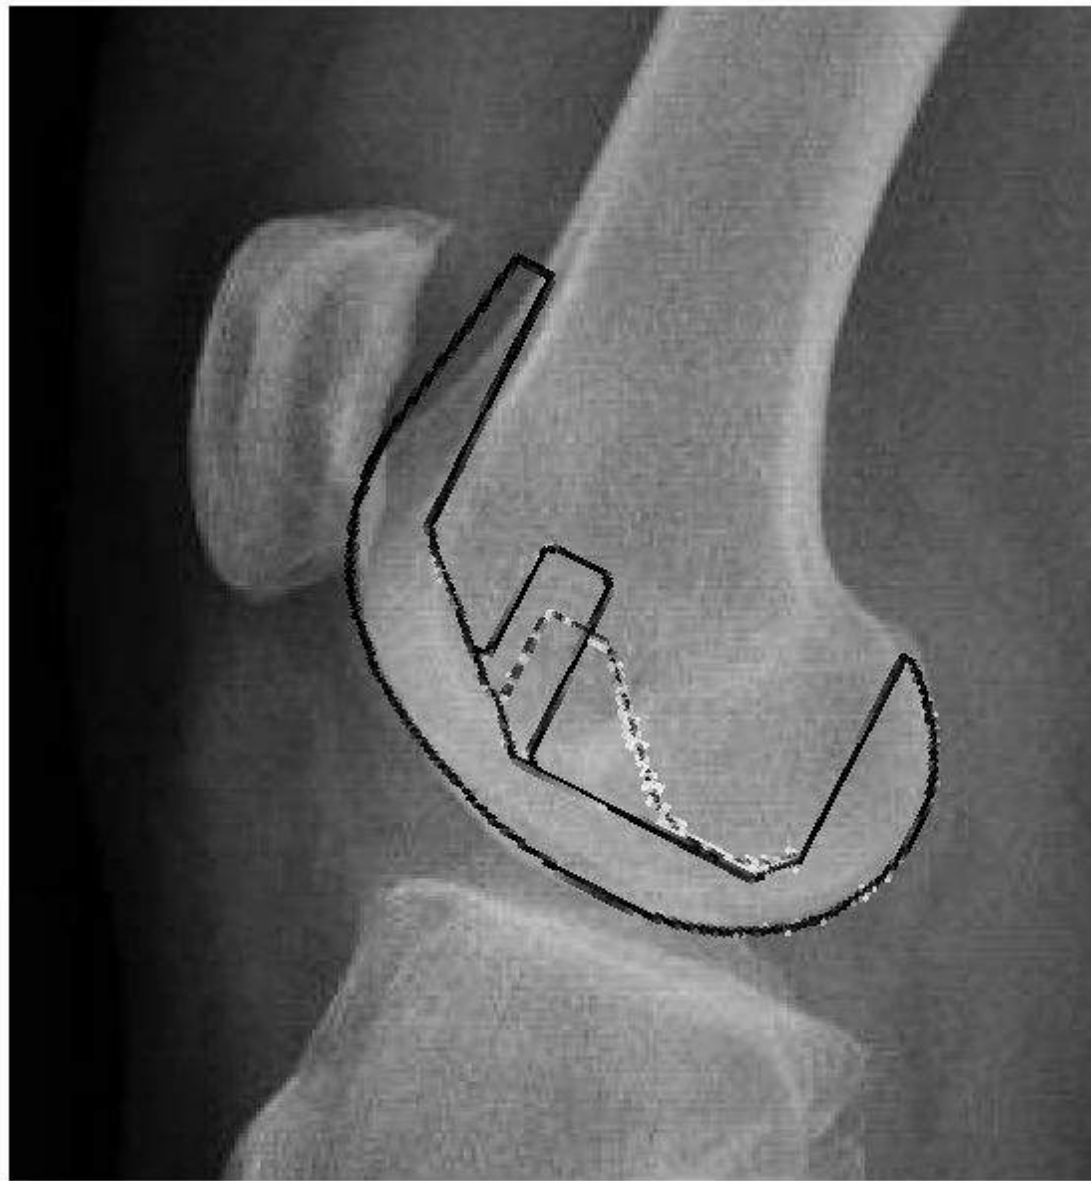
Proper size of the femoral component is assessed via evaluation of the pre-operative lateral radiographs.

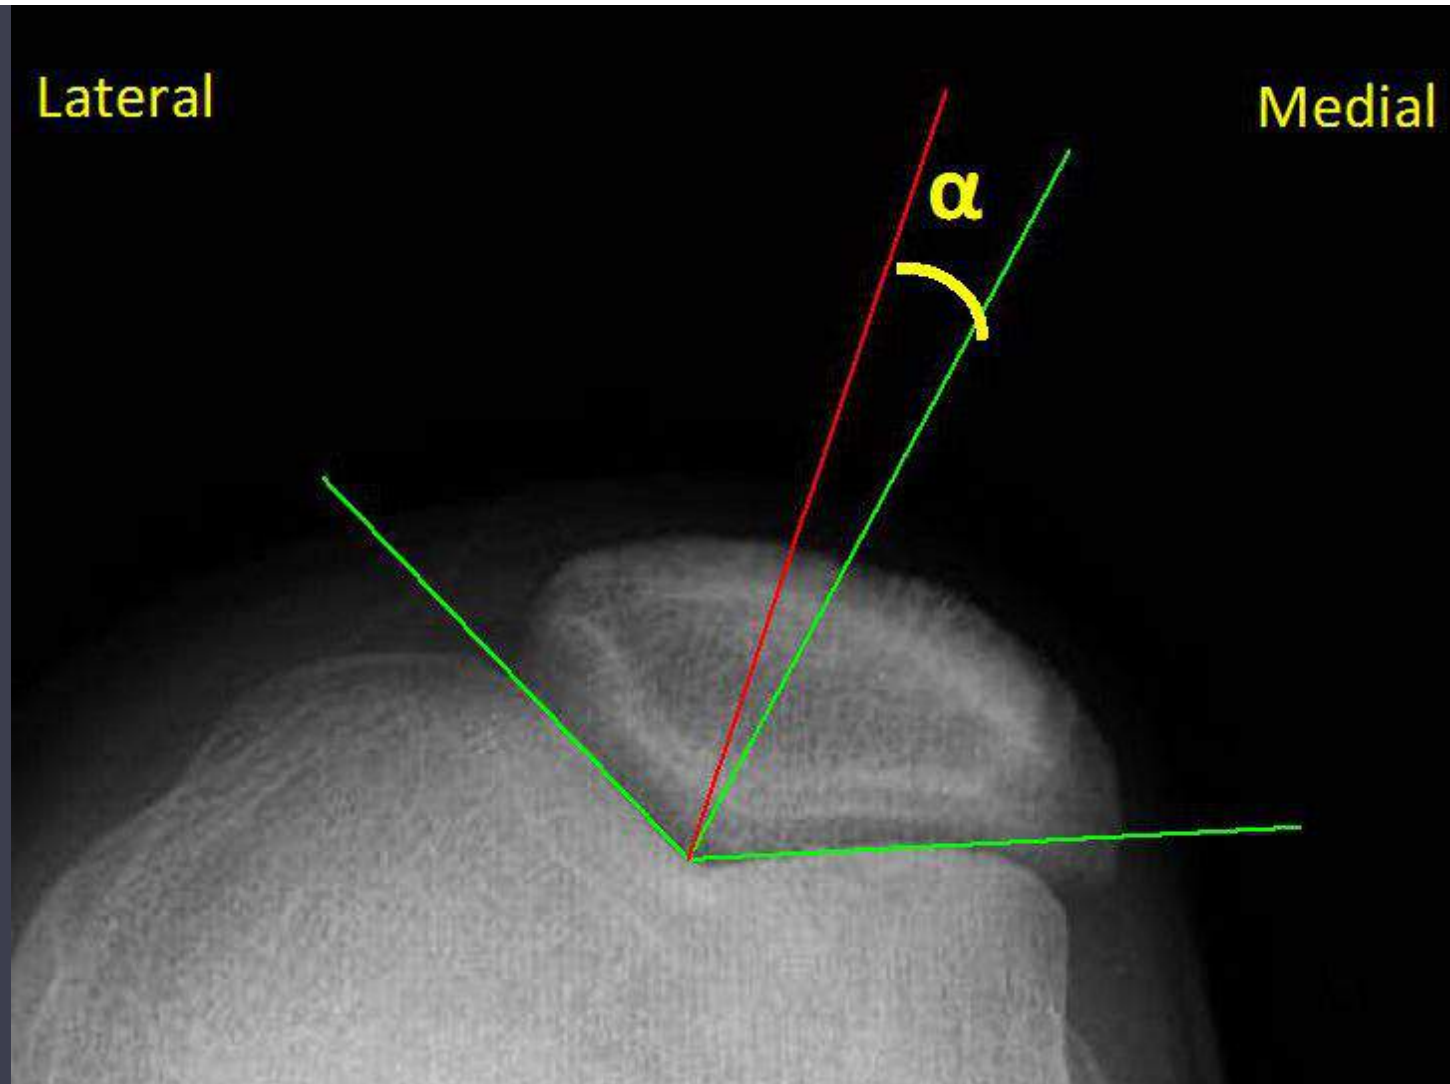
The congruence angle (α) lower than 16° to lateral or medial direction is considered as normal.

If congruence angle is lateral to the reference line this means the angle is positive while angles medial to the reference lines are considered as negative.

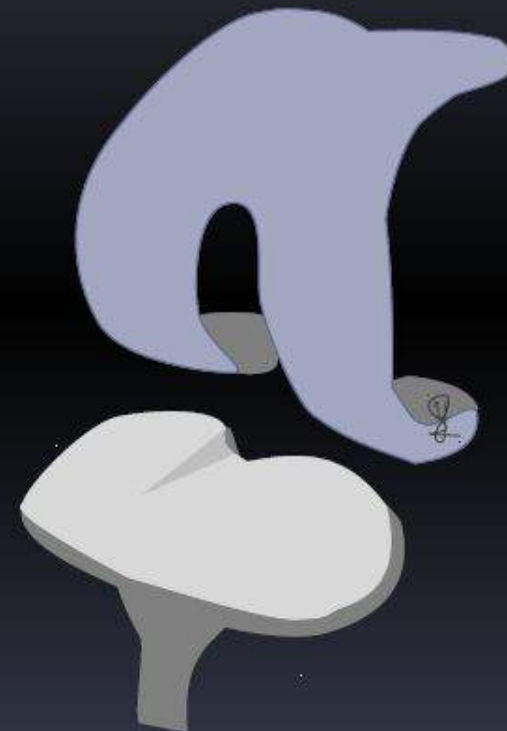
- Also known as
 - Cruciate retaining prosthesis
 - Posterior cruciate ligament (PCL)-Sparing prosthesis
- Most common type
- Femoral and tibial components are not linked
 - Patient's ligaments, tendons and muscles help maintain stability
- Groove in posterior aspect of tibial component to accommodate PCL

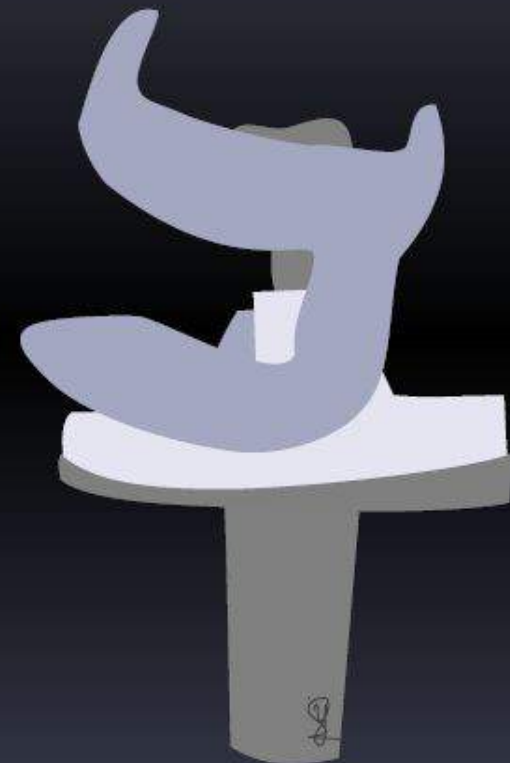
- Sacrifice the PCL
- More stable than a non-constrained prosthesis
- Femoral and Tibial components are linked

Central box like hole between condyles of femoral component

Tibial component has central anterior polyethylene tibial spine

Tibial spine inserts into the hole

Transverse posterior cam in femoral component

- Prevents posterior subluxation of tibia

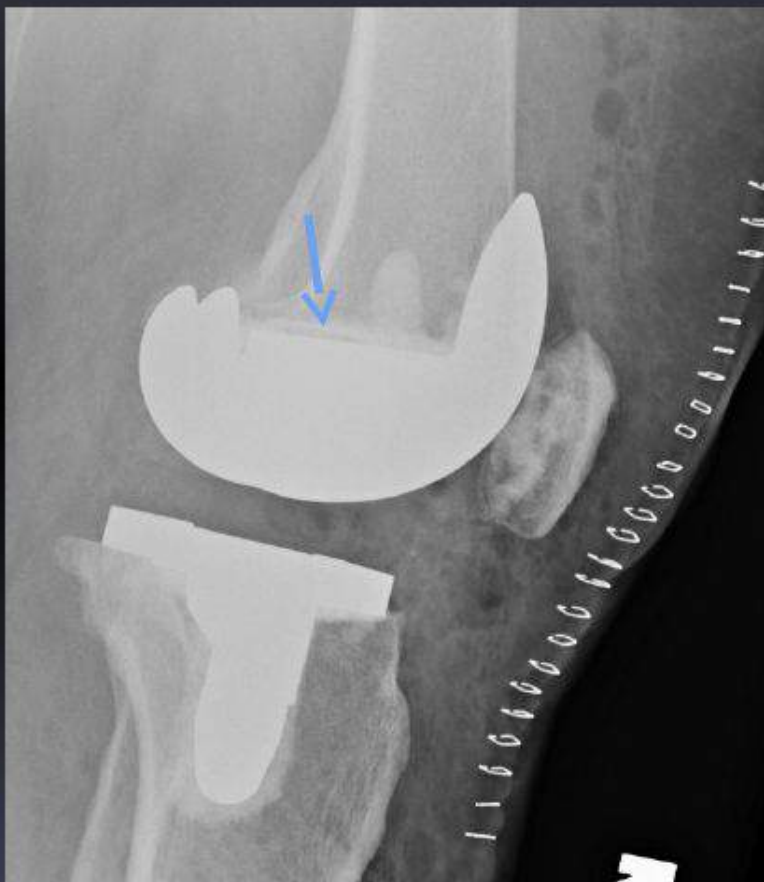
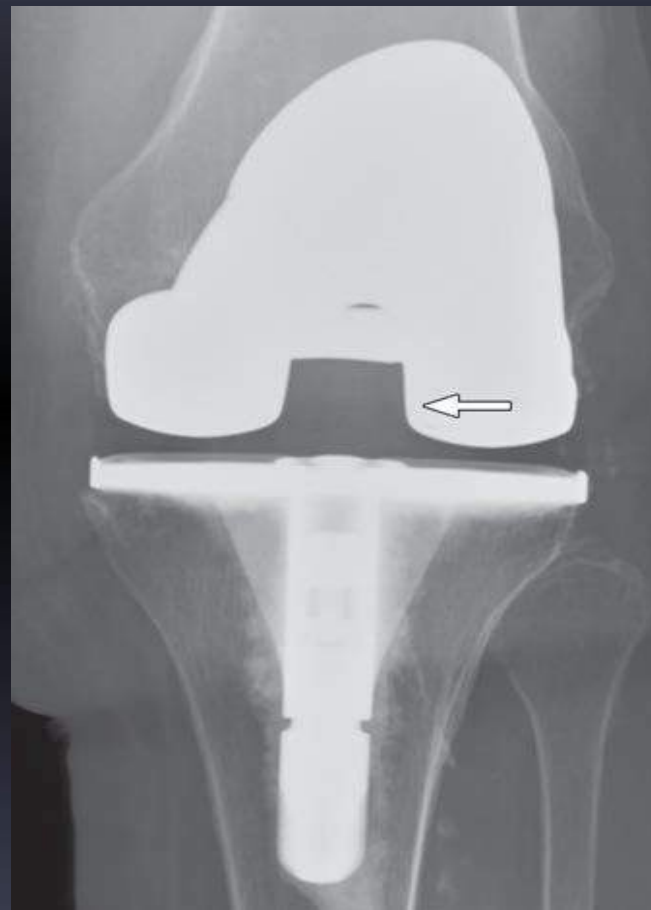
Semi-Constrained Prosthesis

Walls (arrow) of central box-like hole in femoral component allows for distinction between semi-constrained and non-constrained prostheses on radiographs

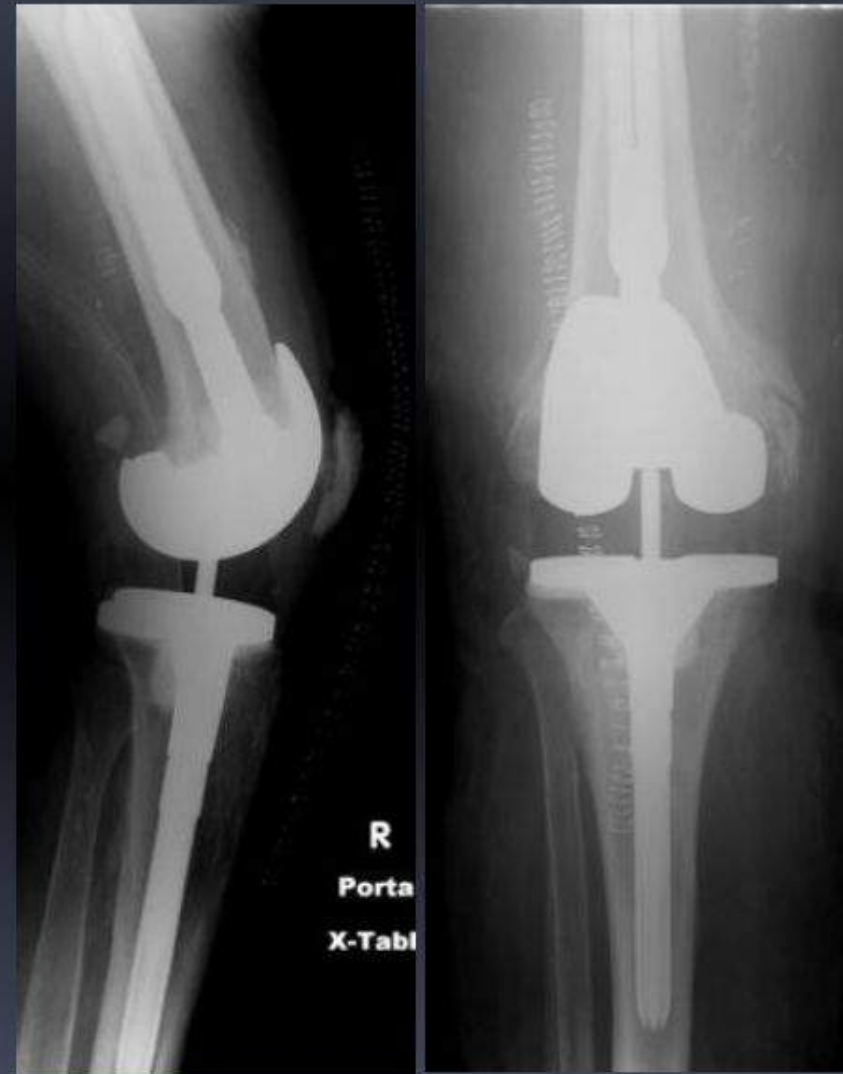
- Femoral and tibial components linked
 - Hinged mechanism
- Usually as revision arthroplasty
- In elderly with highly unstable knees
- With tumor resection surgery
- Higher amount of mechanical stress on components
- Shorter life than less constrained prosthesis

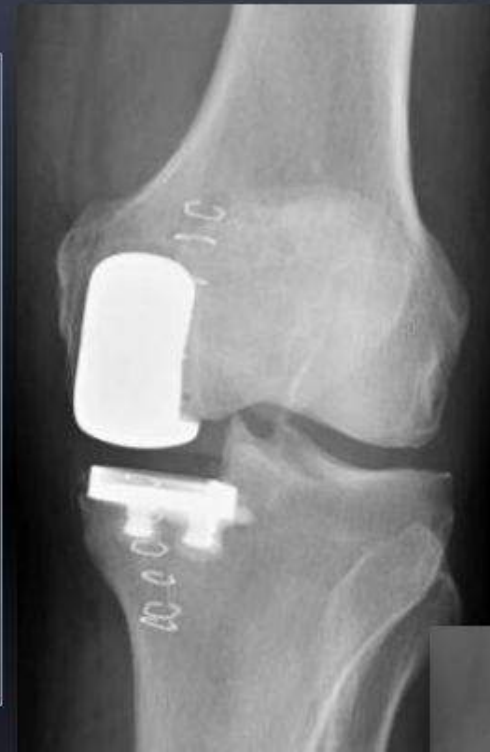
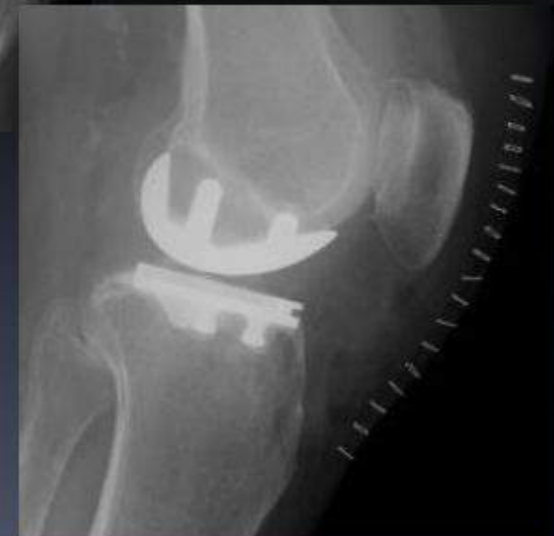
- Resurfacing of one compartment
- Usually for isolated medial compartment disease
- ACL and PCL preserved
- Lack of ACL is a relative contraindication
- Maybe fixed or mobile

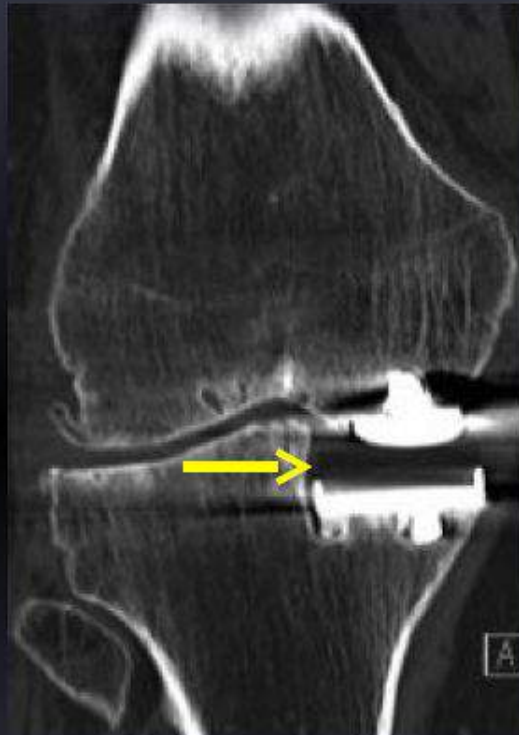
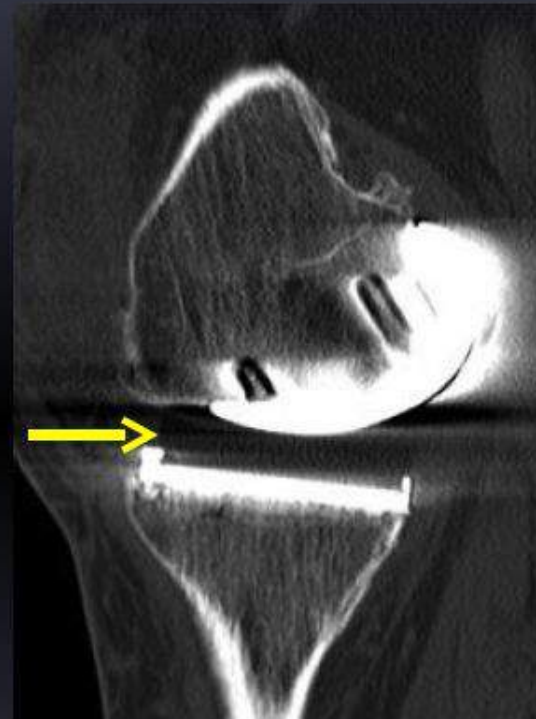
- CT images of unicompartment prosthesis
- Note lucent polyethylene spacer (arrows)

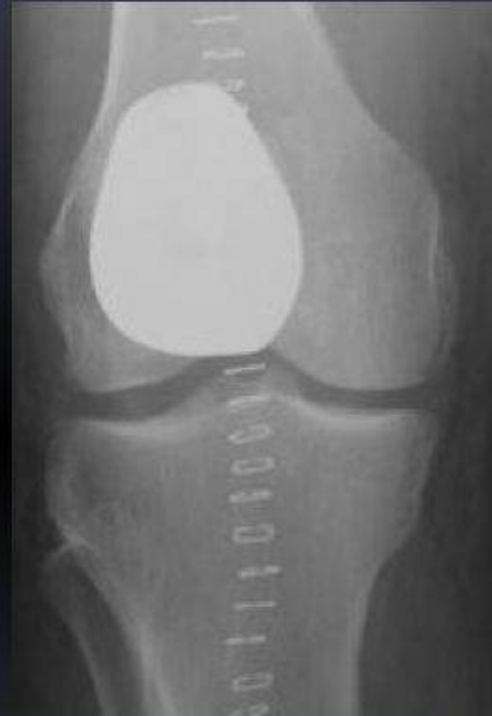
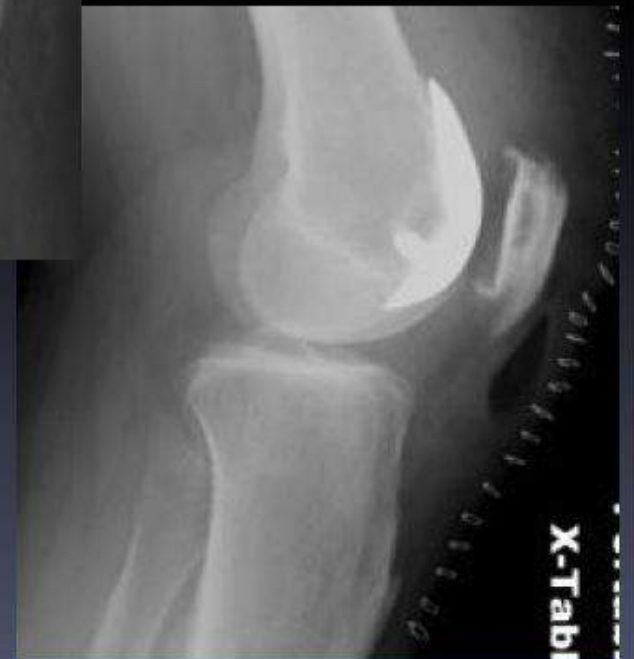
- Patellofemoral arthroplasty
 - May be considered in patients with trochlear dysplasia or patellofemoral malalignment
 - May need revision to TKA with progression of femorotibial osteoarthritis

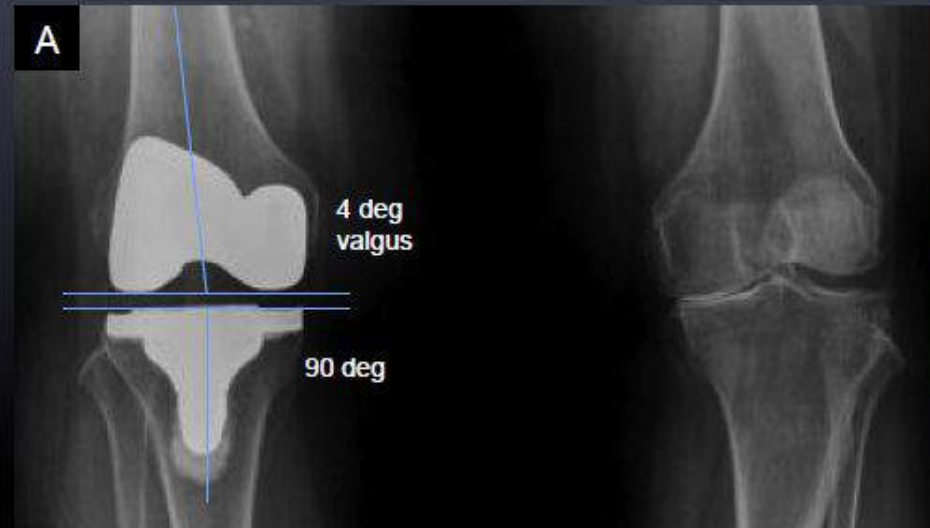
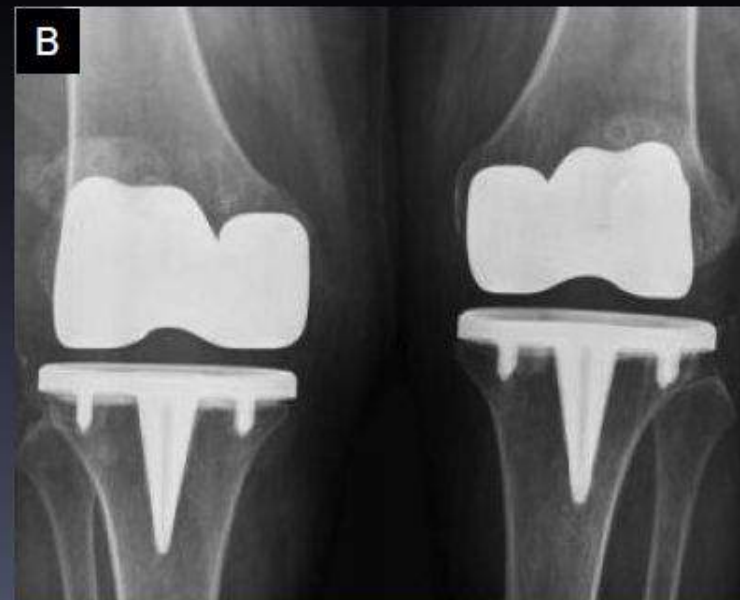
- A: Both knees should be at same level on weight bearing radiographs

- B: Joint spaces at different levels

Femorotibial joint space should be uniform medially and laterally

- Femoral component normal = 7 ± 3 deg in valgus to long axis of femur (A)

- Tibial tray normal = 90 ± 3 deg to long axis of tibia (A)

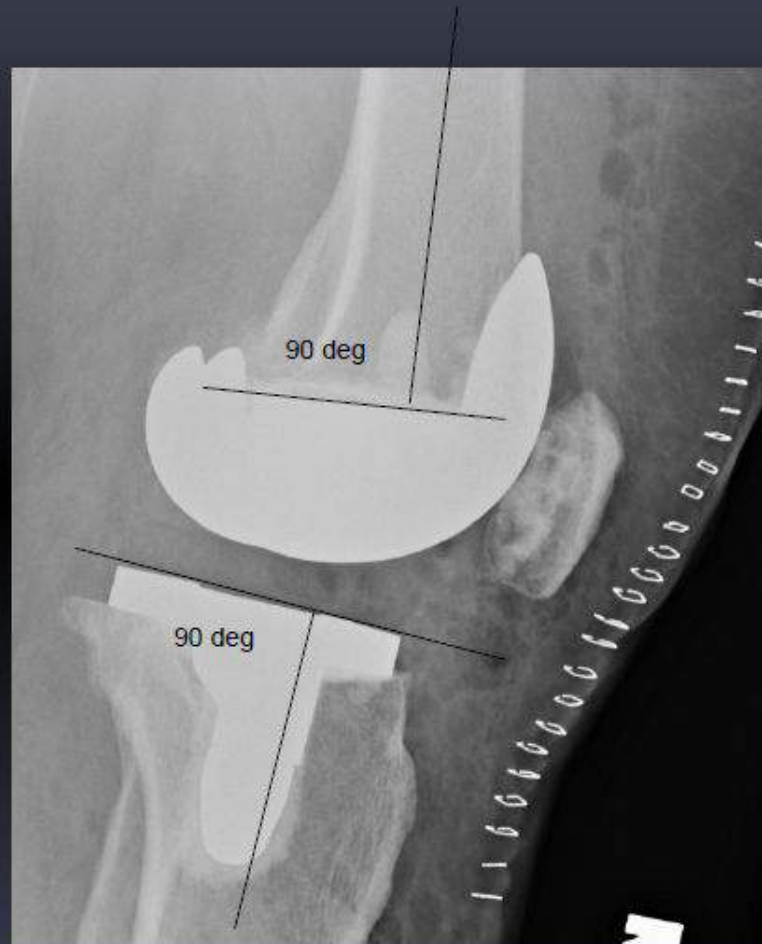
- Horizontal portion of femoral component is 90 ± 3 deg to femoral long axis

Tibial tray perpendicular to long axis of tibia or up to 5 deg posterior tilt

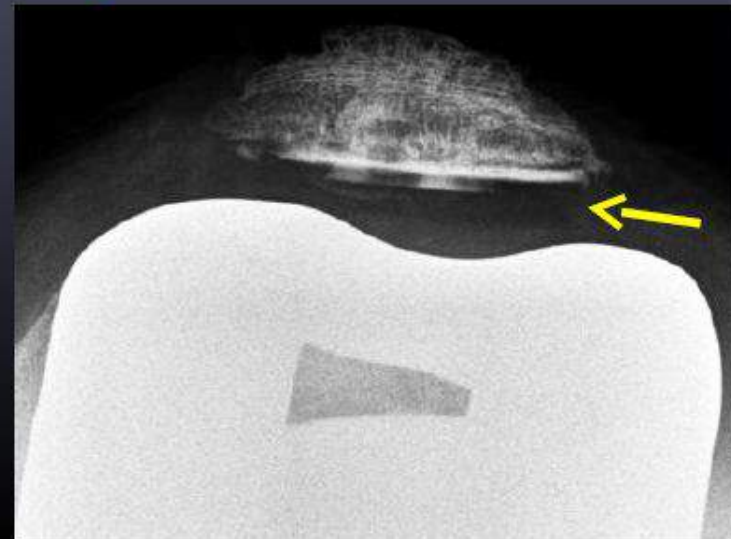
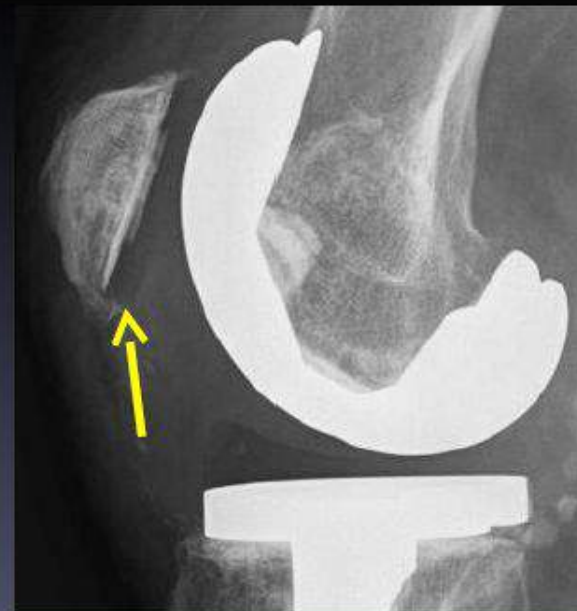
- Merchant View
 - Patellar component (arrows) centered over trochlea
 - Metal backed high density polyethylene in this case

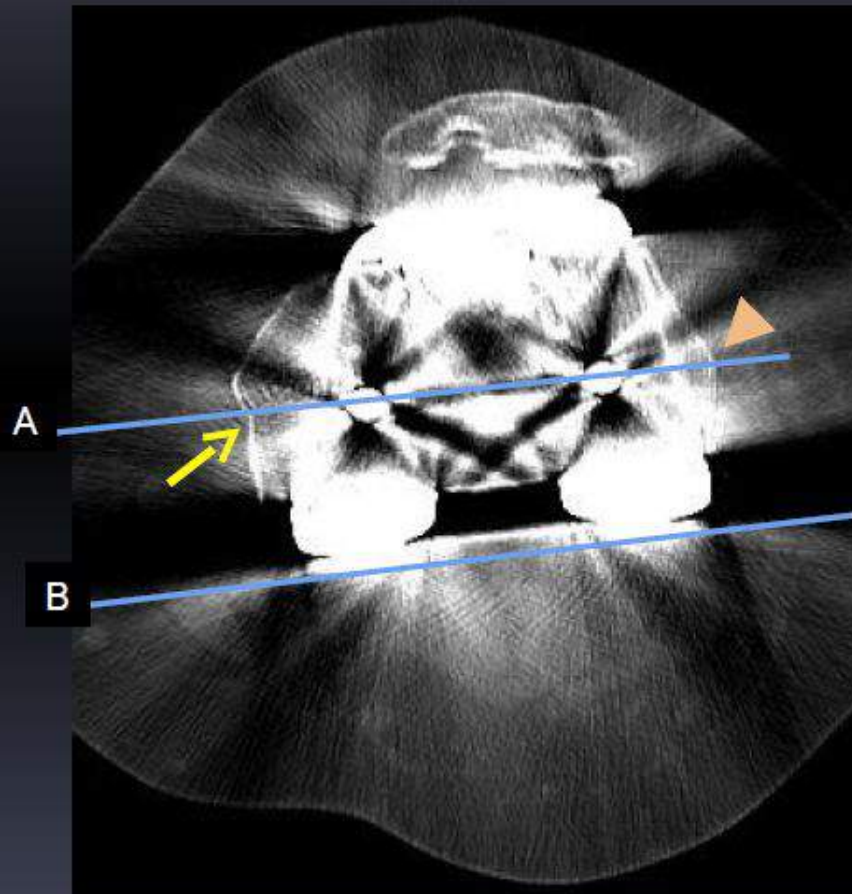
- Femoral component rotation
 - A: Line from medial sulcus (arrow) of medial epicondyle to lateral epicondylar prominence (arrowhead)
 - B: Line along posterior aspect of femoral condyles
 - Posterior condylar angle = Angle between lines A and B
- Normal posterior condylar angle
 - Females = 0.3 ± 1.2 deg internal rotation
 - Males = 3.5 ± 1.2 deg internal rotation

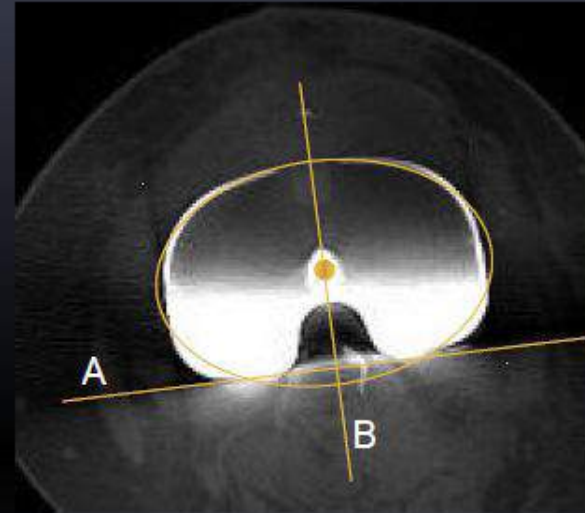
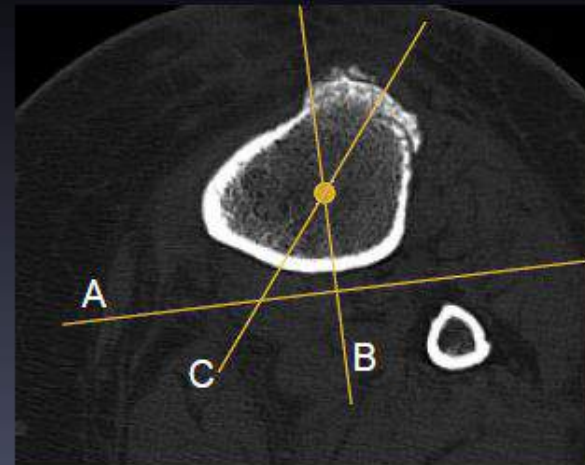
- Tibial component rotation
 - Center of tibial plateau determined = center of best fit ellipse around tibial component
 - Line A = along posterior aspect of tibial tray
 - Line B (perpendicular to Line A) = tibial component axis
 - Transpose center of tibial plateau to axial image through tibial tubercle
 - Transpose line B to image through tubercle
 - Line C = Line from transposed center to tibial tubercle = Tibial tubercle axis
 - Angle between line B and C is the degree of rotation
 - Normal angle = 18 deg internal rotation

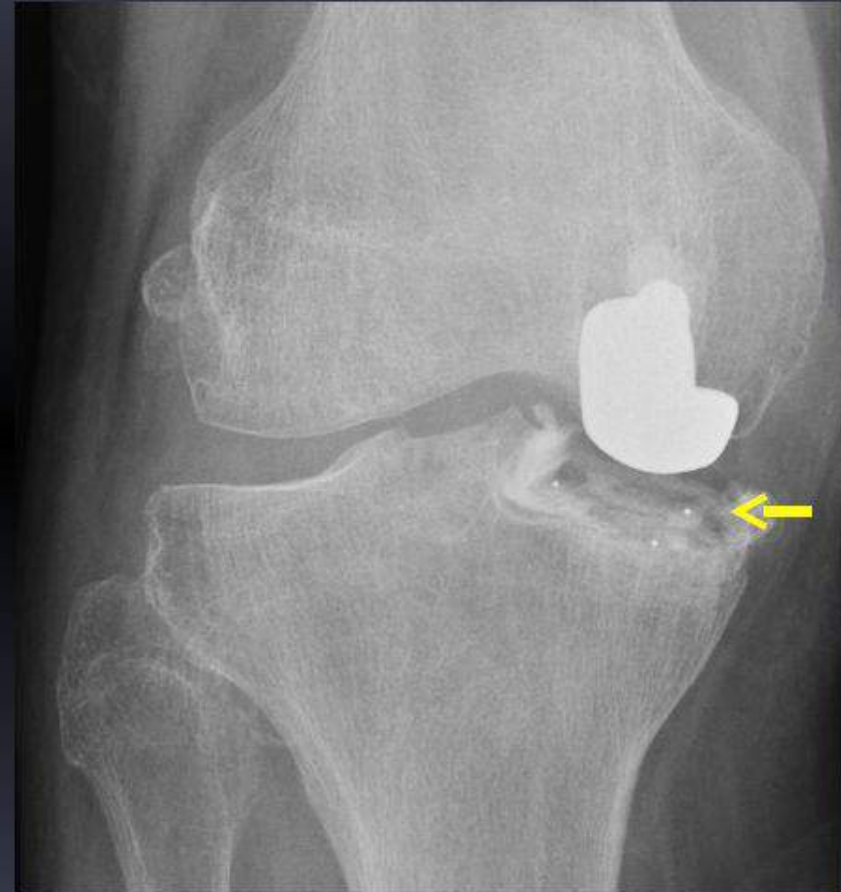
- Most prevalent cause of eventual prosthesis failure
- Wear of liner creates debris and stimulates foreign body reaction
- Leads to synovitis and osteolysis
- With progressive wear asymmetric joint space narrowing
- Eventual metal on metal contact
- Note fragmented tibial component and subsidence (arrow) resulting from polyethylene wear in this patient

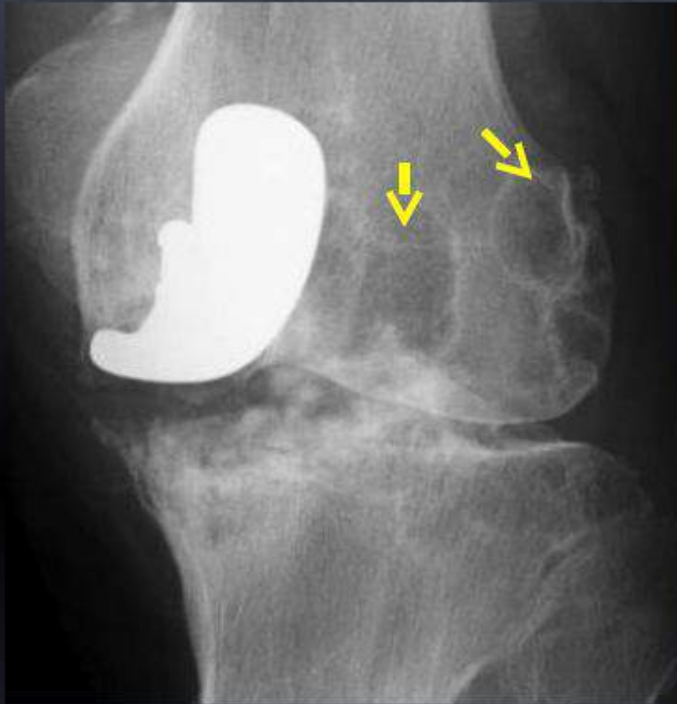
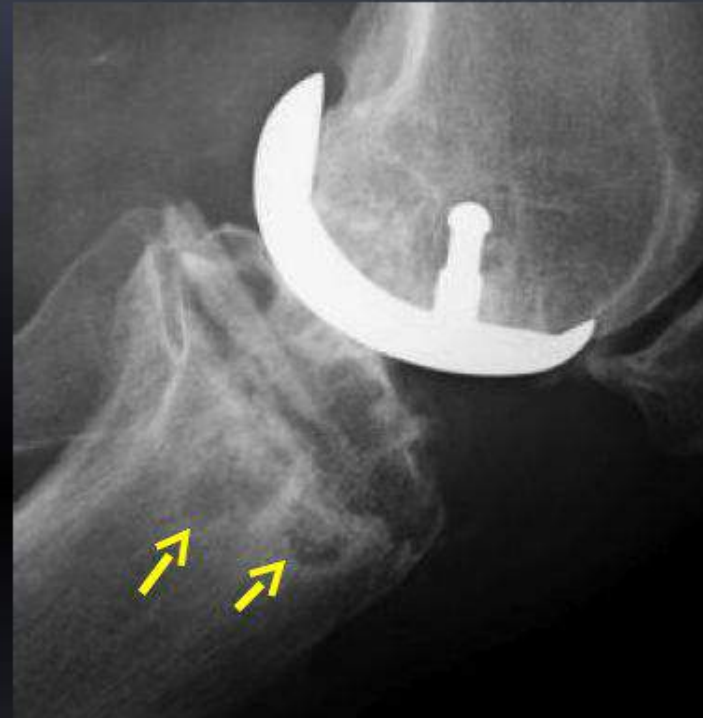
- Response to small particle debris from the implant, especially polyethylene liner
- Multinucleated giant cells and macrophages create a granulomatous reaction
- Results in osteolysis (arrows)
- AKA – Particle disease
- Arthrocentesis and laboratory studies may help exclude infection

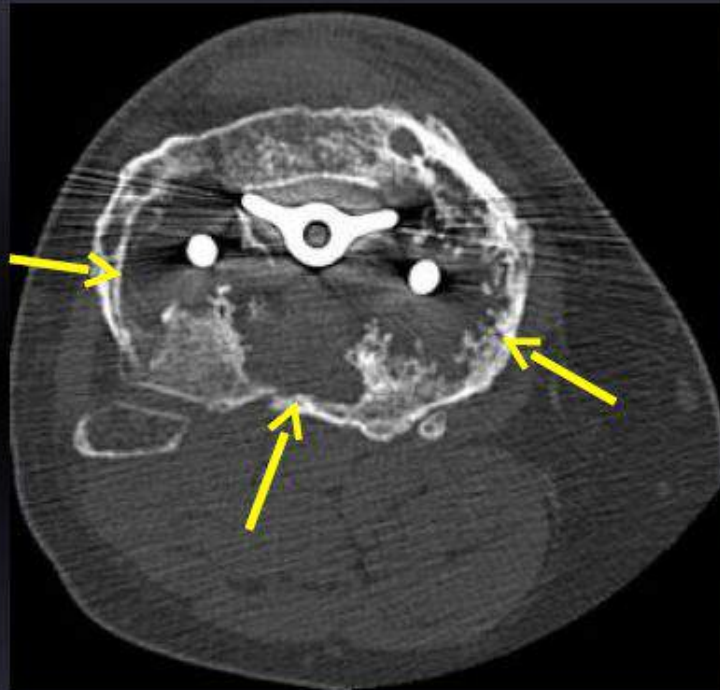
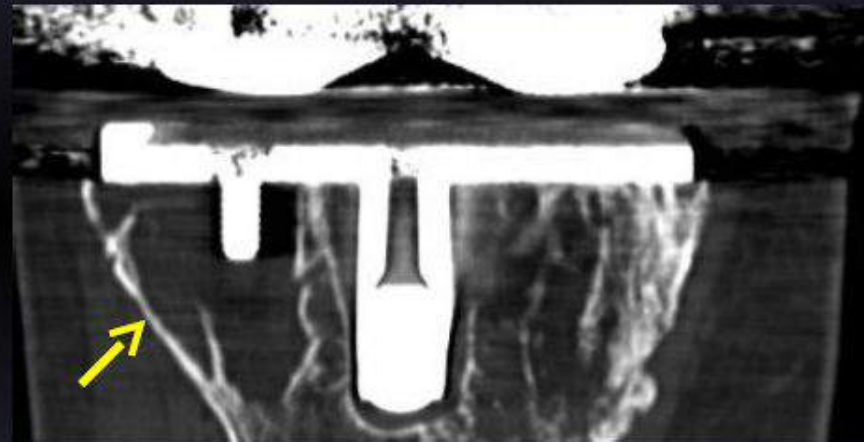
- CT images showing areas of osteolysis in the proximal tibia around the tibial component (arrow)
