PRE & POST-OPERATIVE RADIOLOGICAL ASSESSMENT IN TOTAL KNEE REPLACEMENT

Dr. Divya Rani K
2nd Year Resident
Dept. of Radiology

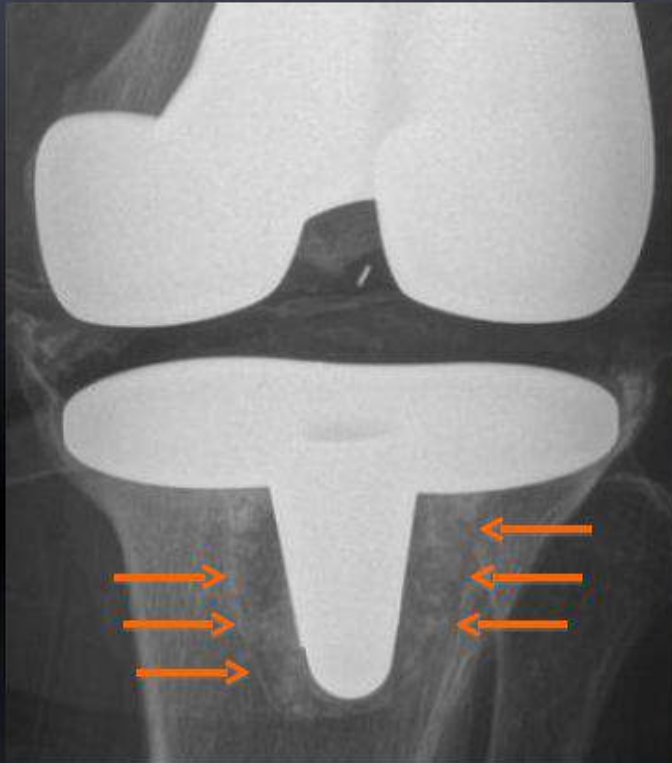
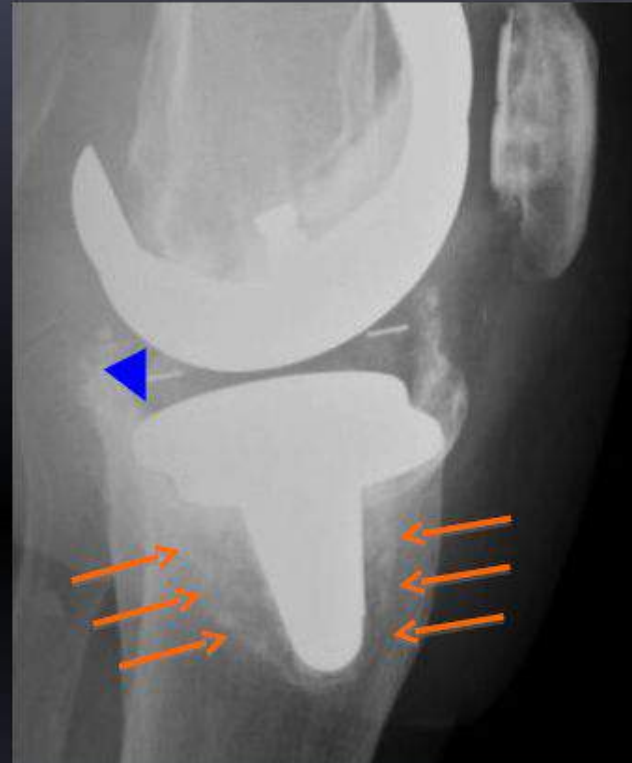
- Failure of bonding between prosthesis and bone without infection
- Progressive widening of lucent region around prosthesis (arrows) greater than 2mm is abnormal
- Uniform lucency less than 2mm may occur within 1-2 years of TKA and remains stable
- Need to exclude infection
- Progresses to subsidence (arrowhead) or migration of components

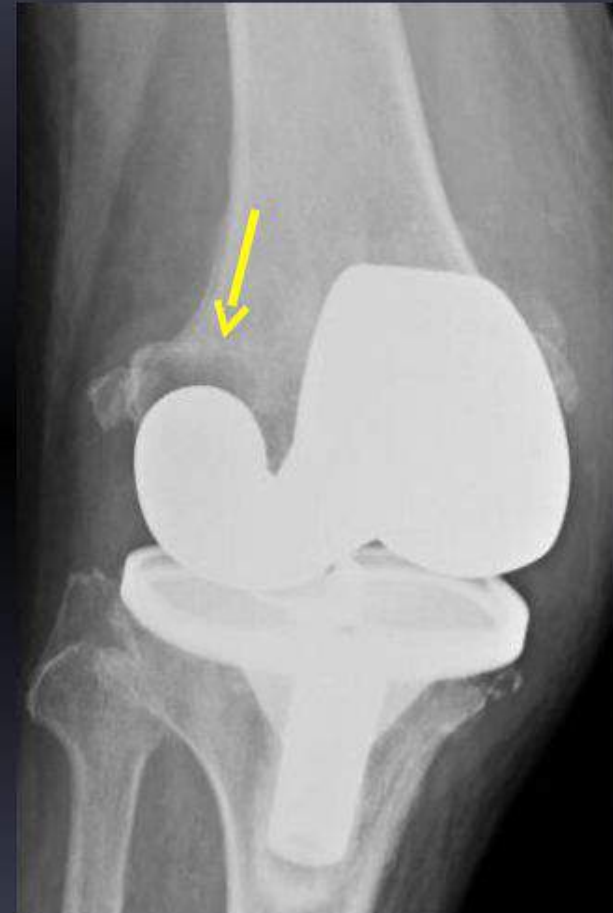
- Patients may present with
 - Soft tissue swelling
 - Erythema
 - Pain
 - Joint effusion
- Radiographic findings
 - Periprosthetic lucency similar to loosening but irregular
 - May appear similar to osteolysis of particle disease
 - Possible effusion
 - Periosteal change
- MRI with STIR imaging or ultrasound may help in detecting an abscess around an infected TKA
- Note focal lucent region around femoral component (arrow) due to infection in this patient

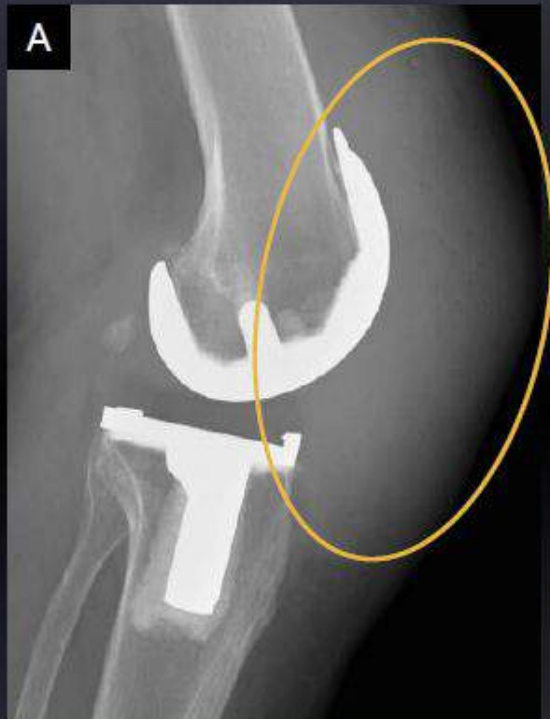
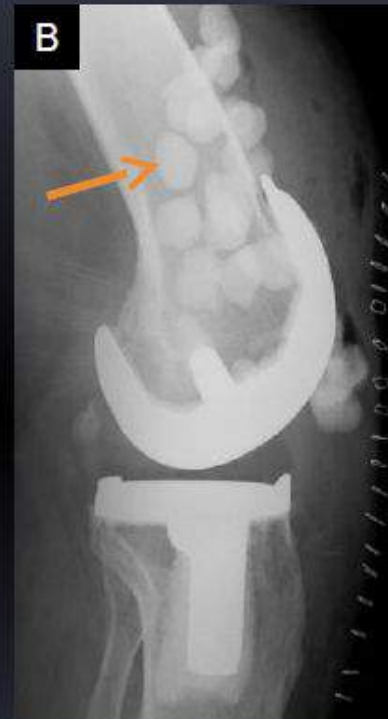
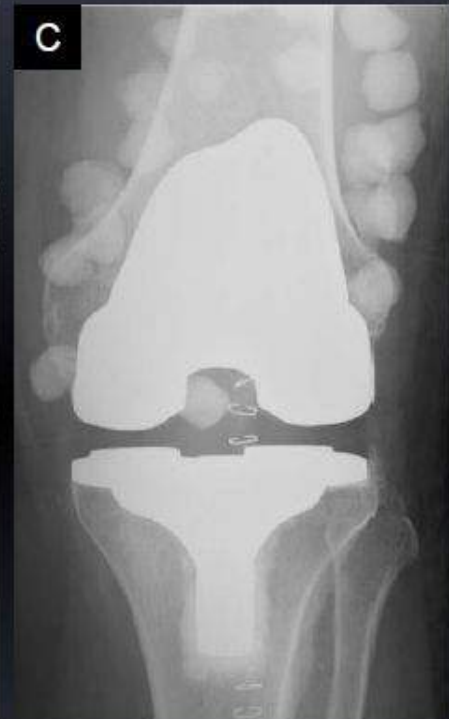
A: Note anterior soft tissue swelling and small pockets of gas (oval) in a patient who had patellar dislocation due to quadriceps tendon rupture. Patella was resected.

B-C: Antibiotic laden beads (arrow) placed after debridement

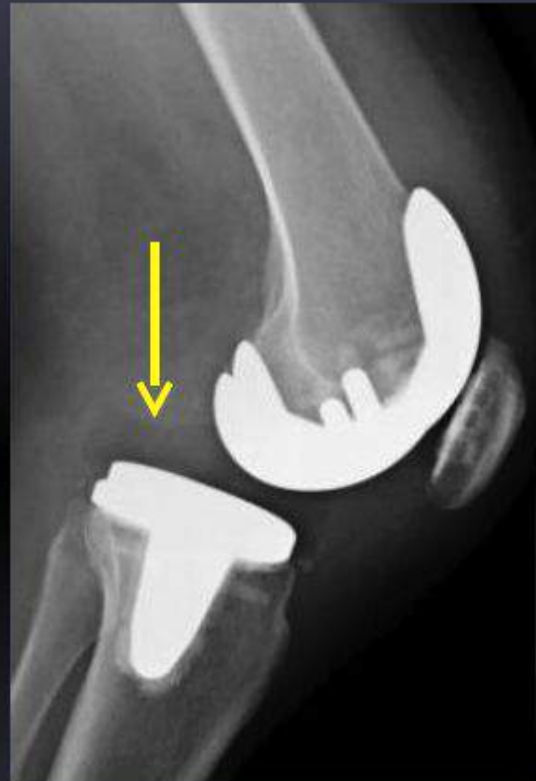
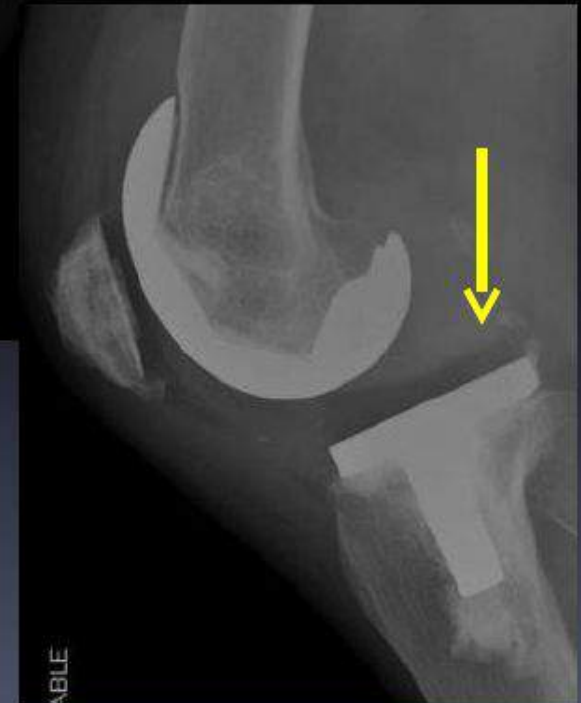
- Causes
 - Malalignment of prosthesis
 - Incompetent ligaments
 - Extensor mechanism failure
 - Incorrect choice of prosthesis
 - Surgical error
- Subluxation or dislocation
 - Note posterior subluxation of tibia (arrows) in two different patients with non constrained TKA due to incompetent PCL

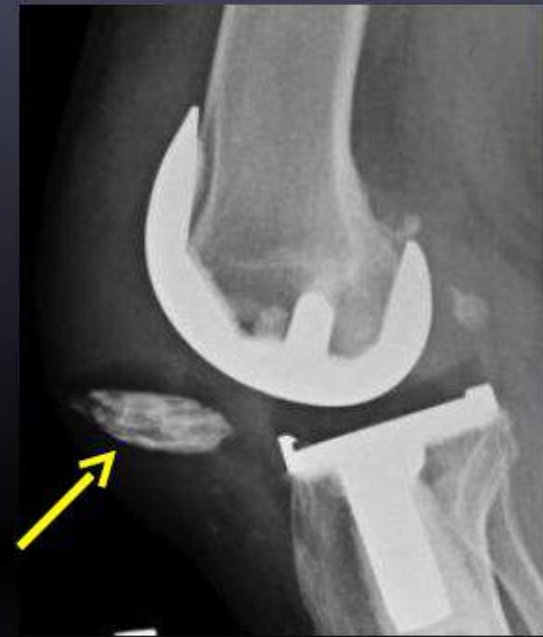
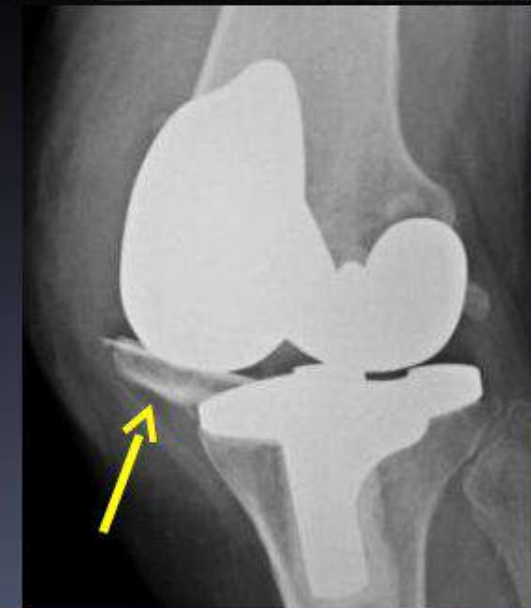
- Causes of patellofemoral dysfunction
 - Malalignment of components
 - Ruptured quadriceps or patellar tendons
 - Patellar fracture
 - Osteonecrosis of patella
 - Component failure
- Metal backed patellar components have higher failure rates than polyethylene backed components
- Patellar dislocation (arrow) in patient with incompetent extensor mechanism

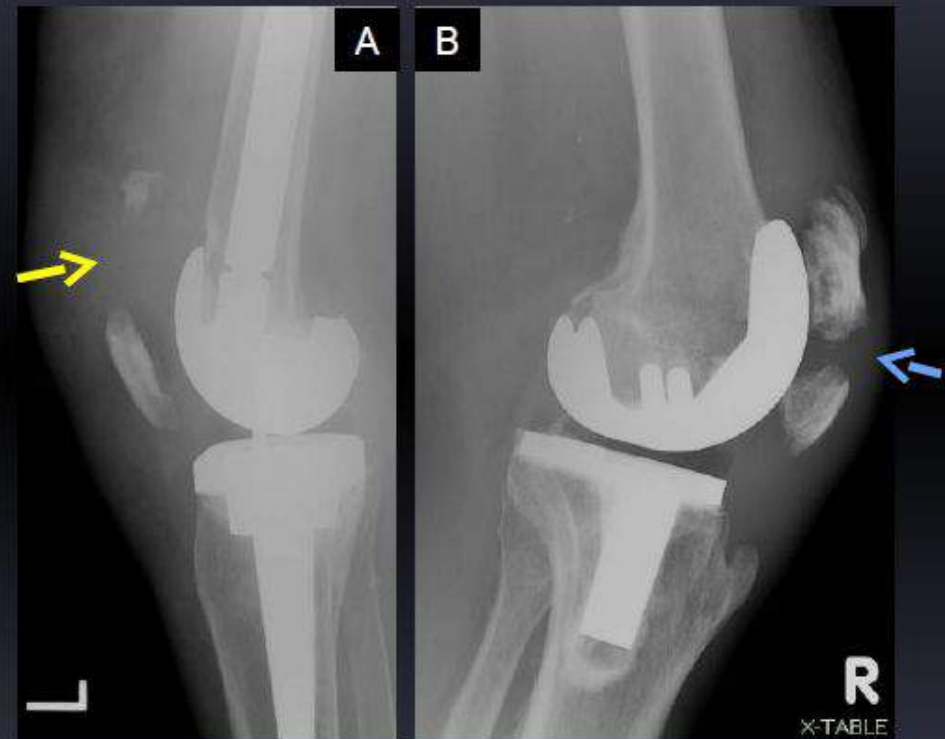
- A: Avulsion of superior pole of patella and proximal migration due to quadriceps tendon (arrow) injury
- Ultrasound is useful in quickly assessing integrity of the quadriceps tendon
- B: Patellar fracture (arrow)

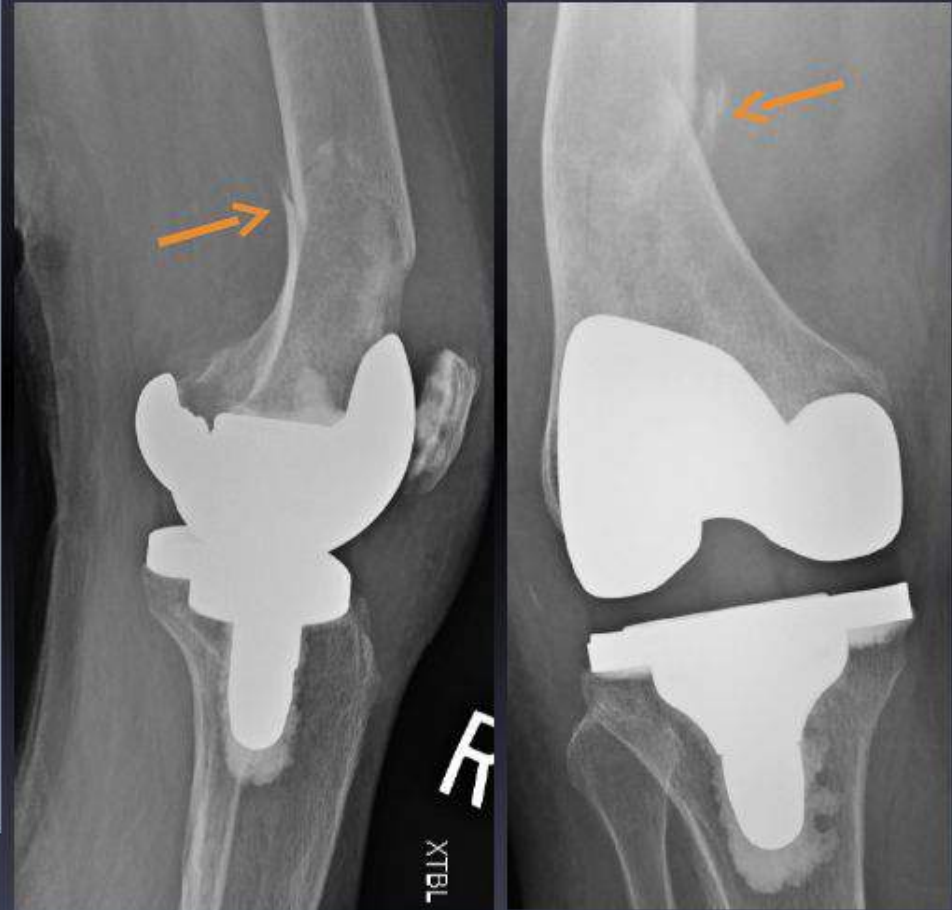
- Causes of fractures include
 - Osteopenia
 - Weakened bone due to osteolysis
 - Elderly patients with increased risk of fall
 - Stresses due to malalignment of prosthesis
 - Long stem prosthesis cause greater stress on bone and increase risk of insufficiency fractures
- Fractures of Femur > Patella > Tibia
- Note femoral fracture proximal to the prosthesis in this patient

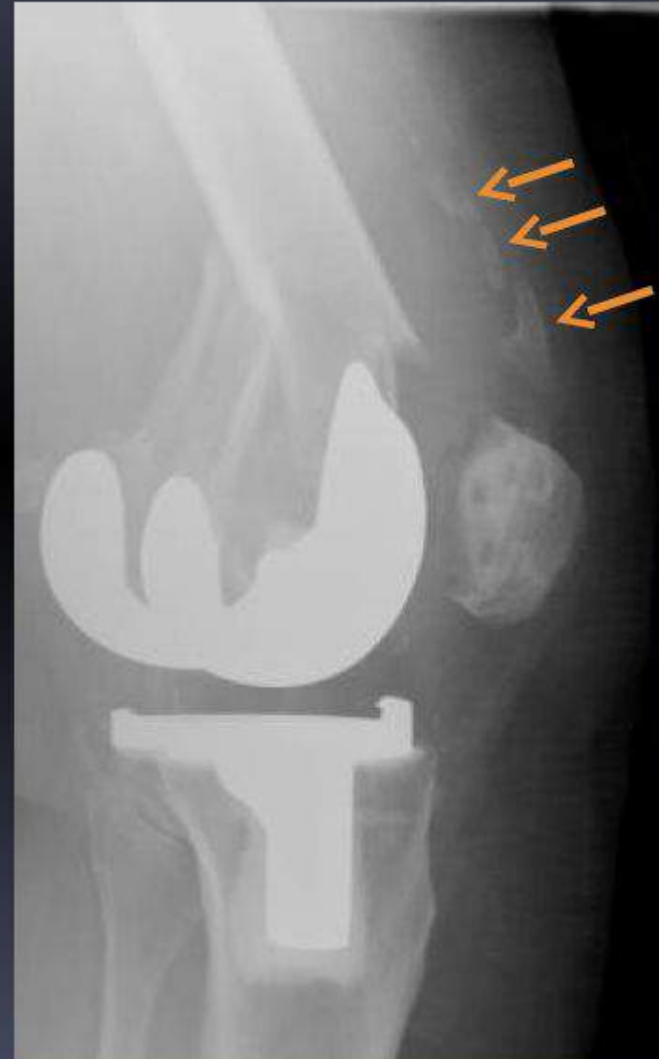
- Common post operative change
- Often along anterior aspect in the quadriceps tendon or muscles
- May cause pain or snapping
- Note islands of ossification (arrows) along the quadriceps tendon in this patient who also has a femoral fracture

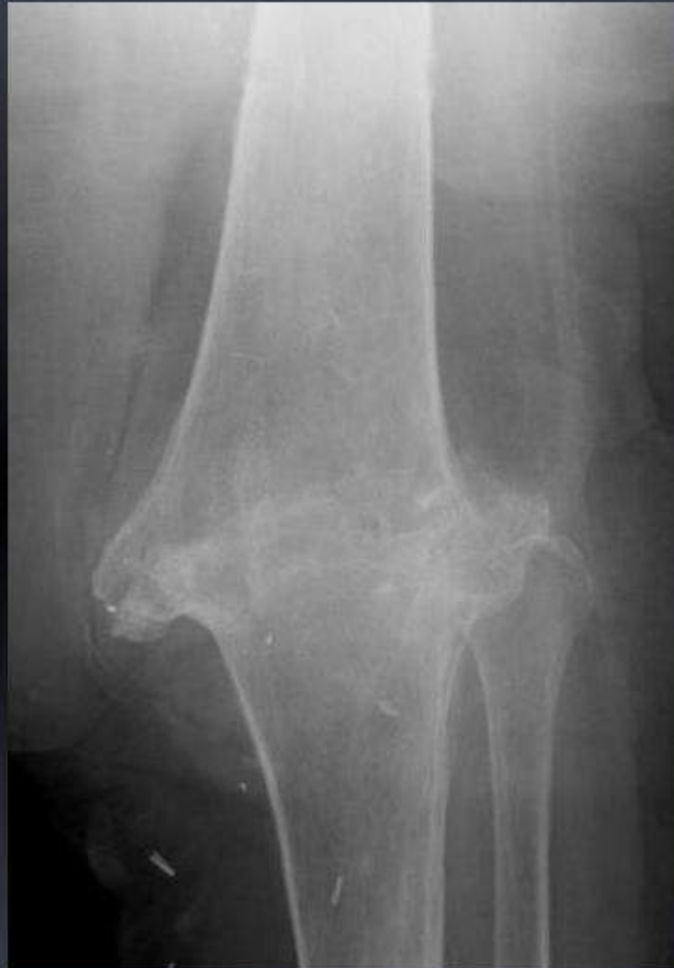
- When all types of knee prosthesis fail patients may go on to arthrodesis
